RESTORATION OF THE ILLINOIS CENTRAL RAILROAD
WOOD WATER TANK AND TOWER, CITY OF KINMUNDY, ILLINOIS

10/2000 TO 6/2001

**RESTORATION OF THE ILLINOIS CENTRAL
RAILROAD WATER TOWER OWNED BY
THE CITY OF KINMUNDY, ILLINOIS
June, 2001**

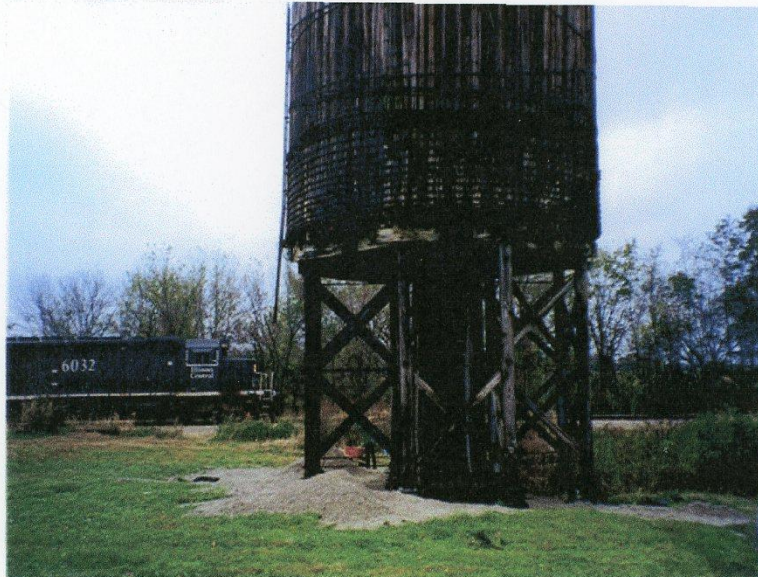
LAST TRAIN BEFORE START OF TEAR-DOWN

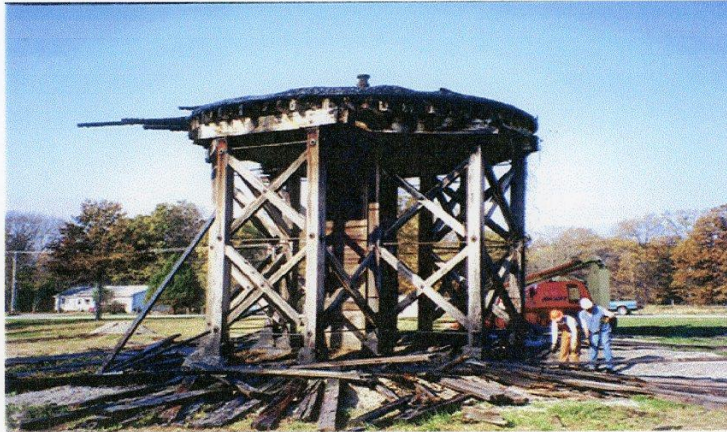
STAVES AROUND BASE OF TOWER

TANK DISASSEMBLY: The hoop nuts were too corroded to allow for removal with wrenches. A decision was made to cut the hoops behind the lugs in order to save the lugs. Each hoop consisted of five rods and lugs, each numbered from #1 at the bottom to #25 at the top. The hoops were then cut away, starting from the top #25 down to #11. Then the bottom hoop #1 up through #3 were removed in order to release the clamp on the bottom head (deck). Next, the #10 through #5 hoops were removed, leaving only the #4 hoop to hold the staves in place. When the #4 hoop was cut, the staves fell outward from their own weight to land radially around the base of the tower.

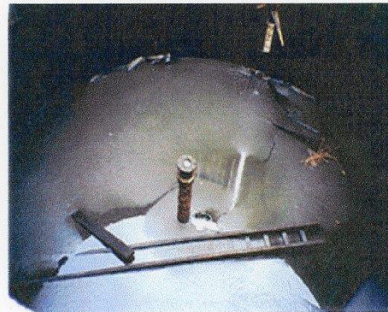
DECK DISASSEMBLY: The 3' x 12' deck boards were in surprisingly good condition. We numbered the deck boards from #1 to #32 and separated them from each other for removal to the ground. Each deck board was doweled at approximately every four feet. There were only two 7-inch long wrought steel spikes used to pin one deck board in place. These spikes were embedded in tar to prevent decay, and they were hardly rusted. The deck boards were scraped and pressure washed on the ground and then stacked on sticks for drying.

DECK: All but 5 of the 32 deck boards were in very good condition. The croze bevel on the majority of the boards was rotten or damaged from 2" to 6" on each end. The deck boards were placed onto the joists and aligned with 1" wood dowels. Galvanized nails were used to secure the deck boards in place because it would not be necessary to squeeze the bottom head as in a conventional tank. The deck was marked and cut. Two layers of 3/4" CCA-treated plywood were then placed over the deck boards and fastened with stainless steel screws.

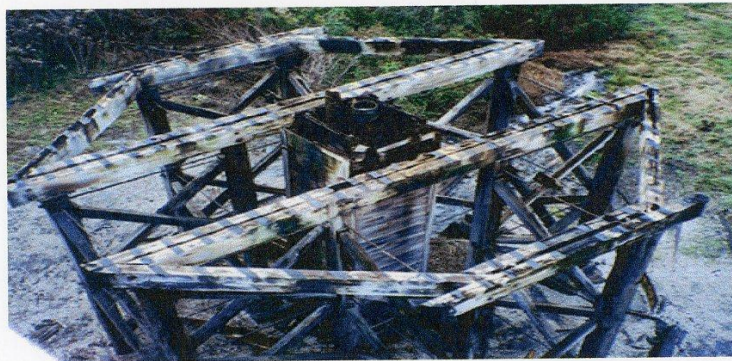
JOISTS (DUNNAGE): The 4' x 14" floor joists appeared to be creosoted yellow pine. All 24 joists were in very poor condition. In many places the exterior shell of the timber was still intact, but the interior was simply a void or sawdust. The joists were laid out on the ground on beams for inspection.

JOISTS (DUNNAGE): Most of the joists were unusable in their original positions. We cut bad long joists to make shorter joists. We resawed replacement joists from bad beams and from used railroad bridge beams. The joists were placed and secured with galvanized common nails used sparingly to prevent future rot sites. The joists were placed to allow for trimming to the required diameter.

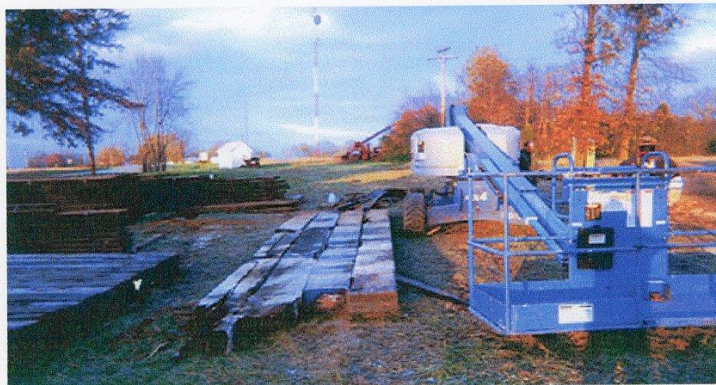
BEAMS DISASSEMBLY: The 7" x 16" main beams appeared to be creosoted yellow pine. They were joined by 3/4" bolts with 3" square wedge blocks at angle joints. The main beams were rotted in many locations. They were stacked on the ground for inspection.

POST CAPS: All 12 of the cast iron post caps were in excellent condition with the IC casting number still visible on each.

BEAMS: The main beams were set onto the post caps and bolted together without any bolt connection to the post caps.

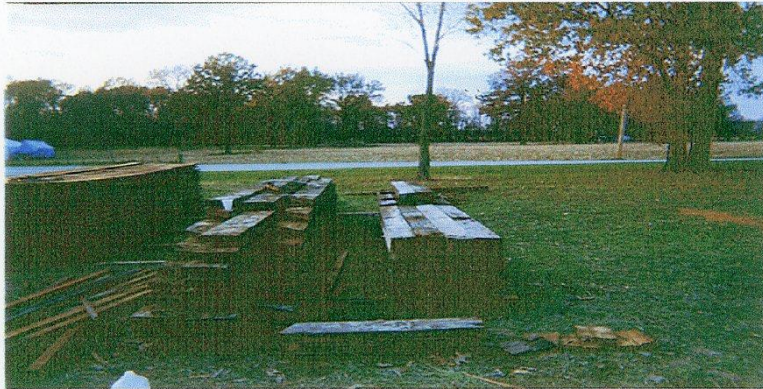
TIE RODS: The 1 1/4" round post tie rods appeared to be in good condition with the exception of some rods near the top of the tank. We were able to remove a few of the tie rod nuts by unthreading but discovered that the rust had bloomed in the holes where the rods passed through the posts. Some of the rods had rusted apart inside the post and none were reusable.

CROSS BRACES: The 6" x 8" cross braces appeared to be creosoted yellow pine. Most of the 48 cross braces were in fair condition. All but three of these were rotted at the lower end where the cross brace nested into the cast iron angle brace wedge shoes.

CROSS BRACES: Due to the structural importance of the cross braces, all 48 cross braces were cut from new, CCA-treated yellow pine. The cross braces were installed between the posts with the wedge shoes. The tie rods were then adjusted to clamp the cross braces and level the posts. The temporary cross braces were removed and the post caps were placed without any anchors over the posts.

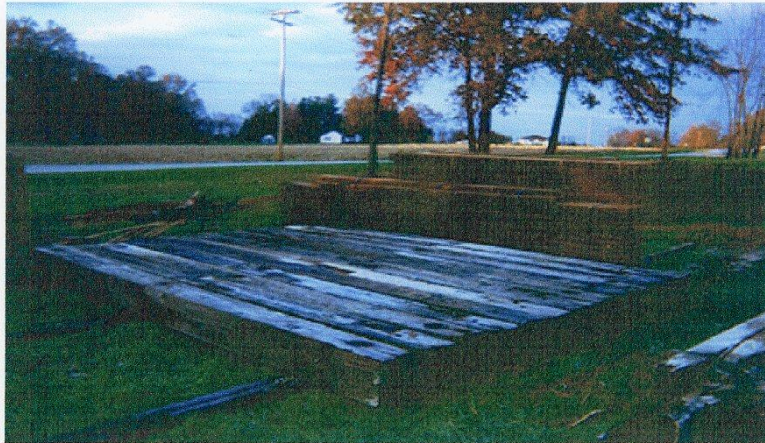
WEDGE SHOES: Of the original 96 cast-iron angle brace wedge shoes, 86 were recovered. They were all in good condition for reuse.

SUPPORT POSTS: The 12" x 12" main support posts also appeared to be creosoted yellow pine. Seven of the twelve posts were in good condition. Several posts were splayed at the bottom and five had rot from the bottom up a few feet. The support posts were numbered and laid out on ground beams.

POSTS: Six inches were trimmed off all 12 posts to eliminate the splayed ends. Five of the support posts were placed on a portable band saw in order to cut out the sections of rot. A replacement block was glued and doweled into each cutout and the post was again placed on the band saw for finish shaping of the patch block. The posts were erected with temporary cross bracing while the new tie rods were installed.

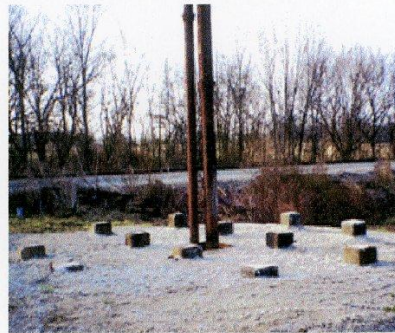
FOUNDATION: The original concrete piers were in very good condition except for surface spalling. City of Kinmundy personnel compacted some crushed limestone around the piers to ensure their continued stability and to drain water away from the foundation. Remarkably, all 12 piers were within 1/2' of being level.
